#### COMPLIANCE EVALUATION INSPECTION REPORT

Compliance Evaluation Inspection: Chenango County Landfill

Inspection Date: July 17, 2014 Inspection Time: 10:30 AM – 3:00 PM

Site Information: Chenango County Landfill

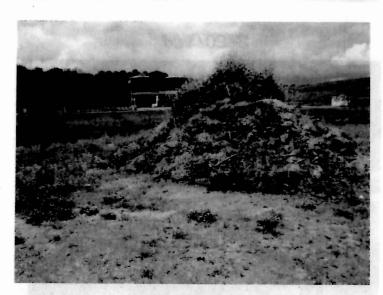
P7170312	Leachate loading dock and rinse area (collected rinse water is pumped back into
	leachate collection system)
P7170314	Eutrophication next to outfall structure in Pond A
P7170316	Outfall 001 from Pond A (green algae observed in discharge)
P7170317	Unnamed tributary of Fly Meadow Creek near outfall 001
P7170319	Compost pile next to Pond A
P7170320	
P7170328	Uncovered scrap metal dumpster
P7170329	Uncovered scrap metal dumpster
P7170334	Refrigerators and air conditioners stored on the pavement near the scale house
P7170335	Outfall 002 from Pond B
P7170337	Flow path from Outfall 002 south towards the unnamed tributary of Fly Meadow
	Creek
P7170338	Outfall structure in Pond B
P7170340	Floatable debris (bags, wrappers) identified in the drainage ditch upstream of
	Pond B
P7170344	Floatable debris at the foot of the temporarily capped area up-gradient of the
	drainage ditch flowing to Pond B
P7170346	Close-up of floatable debris at the foot of the temporarily capped area with
